# PROJECT REPRESENTATIVE'S DAILY REPORT

Pg. 1  
 Report No. 014  
 Date: 2014-09-05  
 Day: Friday

**Architect:** Kang Associates  
**Project:** Renovation and Addition to Tewksbury Town Hall  
**OPM:** CBI Consulting Inc. **Clerk of the Works:** Jeff Barnes  
**Contractor:** G.V.W., Inc.

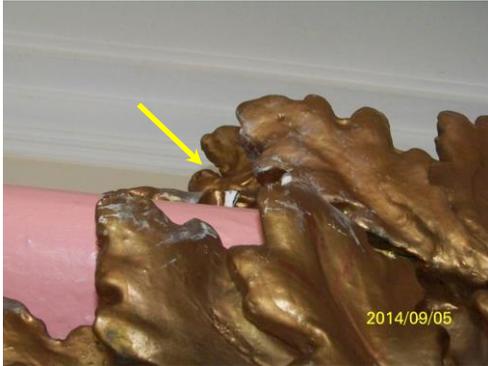
The seal was reviewed today and an attempt was made to remove it until the poor condition of the plaster was noted.

Photo showing a crack in the left side of the town seal.

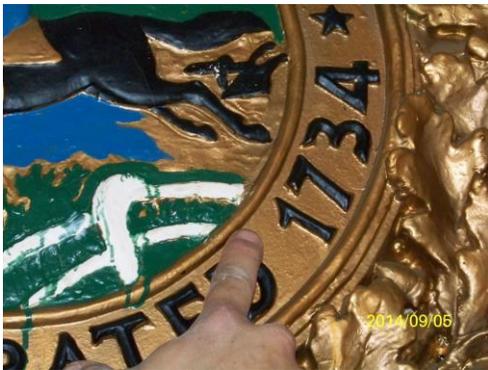
Photo showing a hair line crack in the bottom right quadrant of the town seal.

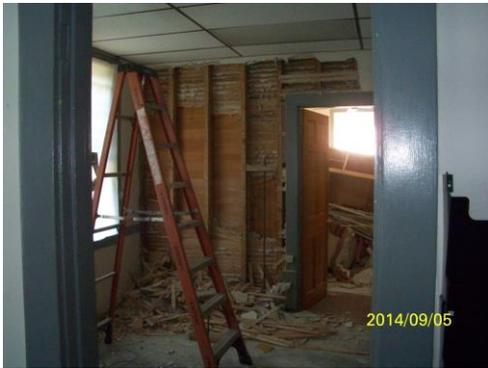
Photo showing the start of the demo to remove the bookcase.

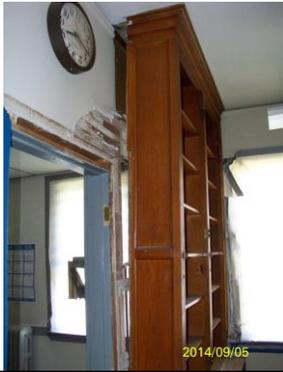
Photo showing the extent of demo at the end of the day. The bookcase has been removed from the wall.

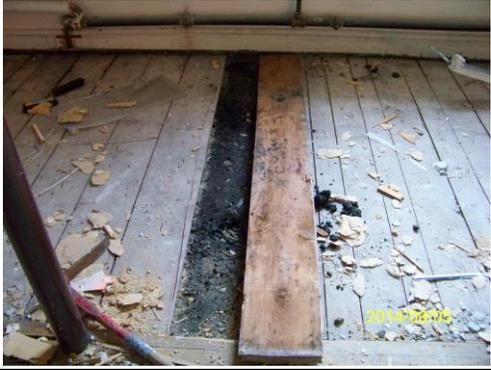
GVW continued demo in the basement. The majority of the basement is demolished. The basement demolition should be finished up by the end of next week. One board in the basement was removed to expose the substrate. The substrate appears to be an asphalt/tar soaked dirt that was compacted.

Photo showing one of the wood planks in the basement removed to expose the substrate beneath. The substrate appears to be asphalt or tar soaked dirt that was compacted. It can be easily broken up.

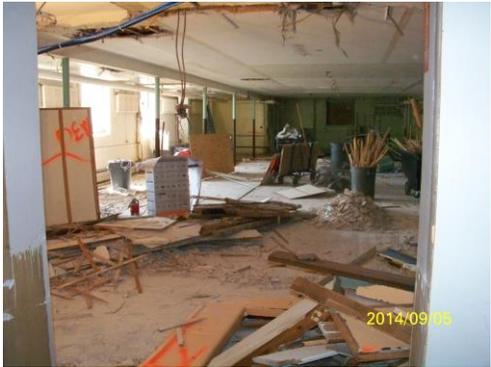
Photo showing the basement gutted looking west.

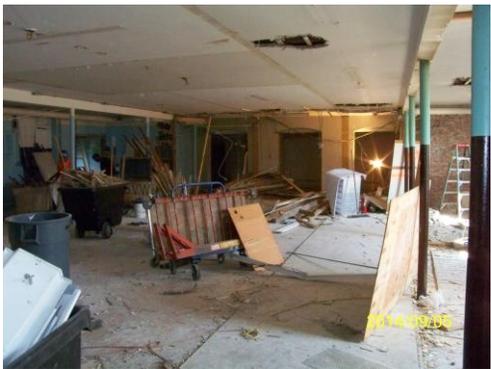
Photo of the basement that has been gutted, looking east.

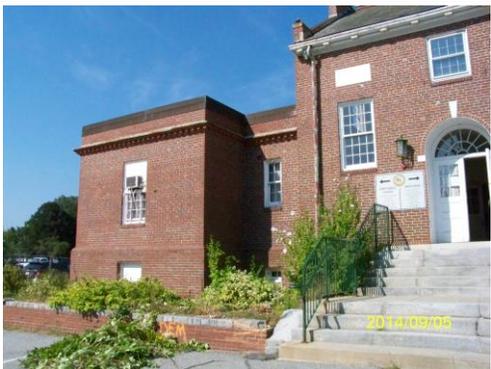
Photo showing the vines removed from the east elevation.

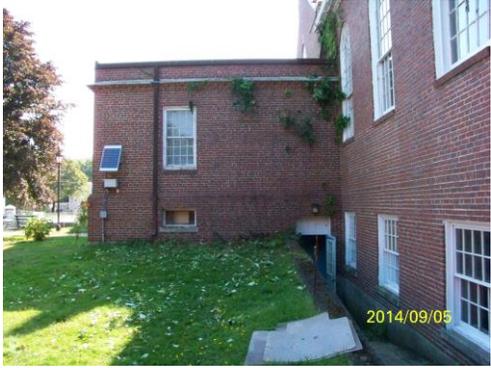
Photo showing most of the vines removed from the north elevation.

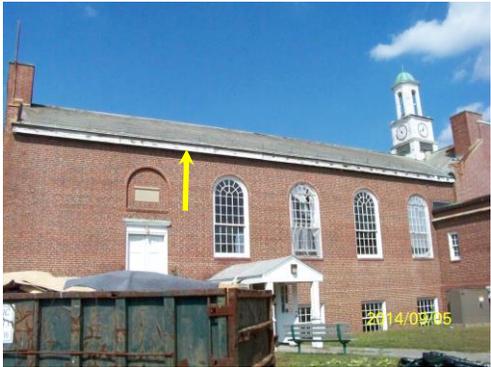
Photo showing the gutter and soffit removed from the south elevation.
