PROJECT REPRESENTATIVE'S DAILY REPORT

Pg. 1
 Report No. 032
 Date: 2014-10-01
 Day: Wednesday

Architect: Kang Associates
Project: Renovation and Addition to Tewksbury Town Hall
OPM: CBI Consulting Inc. **Clerk of the Works:** Jeff Barnes
Contractor: G.V.W., Inc.

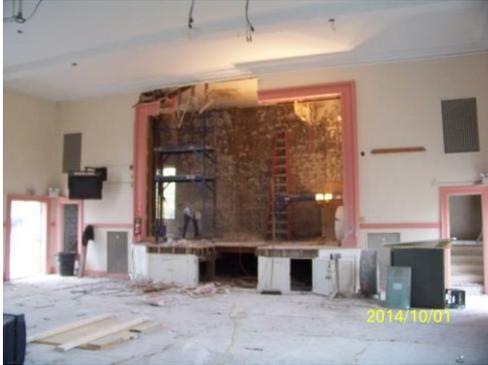
Photo showing the stage in process of being demolished.

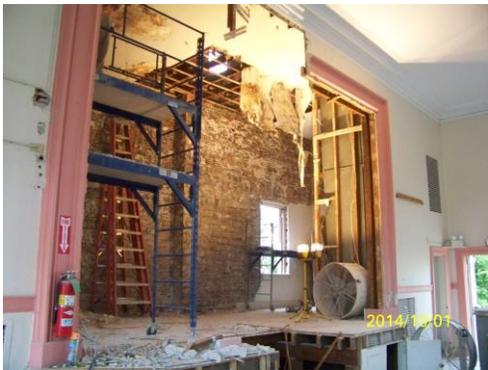
Photo showing the stage being demolished.

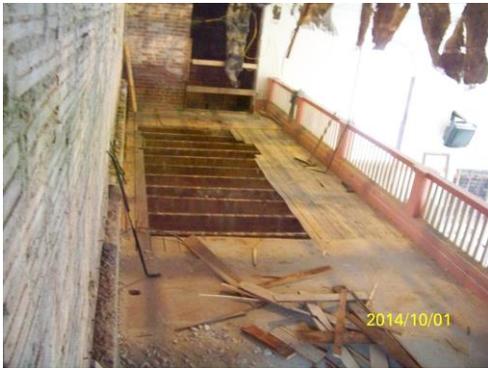
Photo showing the balcony floor being removed.

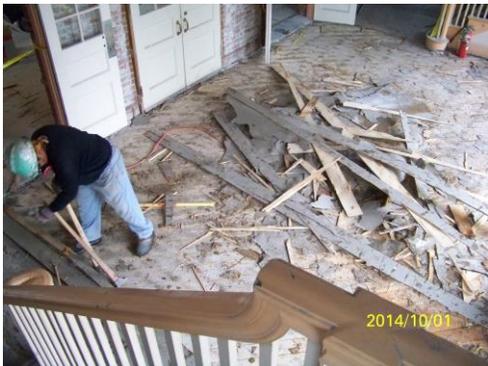
Photo showing the flooring in the lobby being removed.

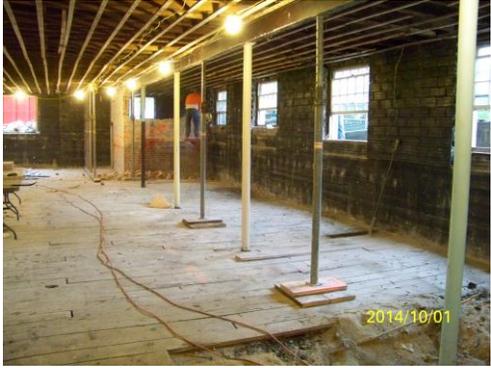
Photo showing shoring posts installed.

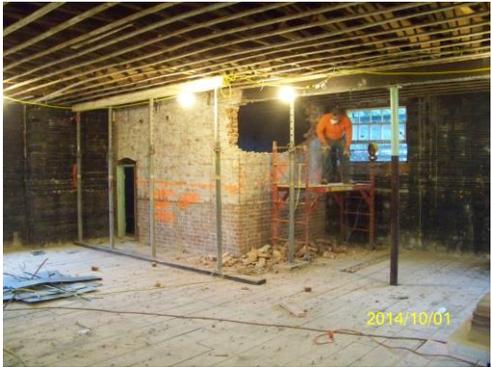
Photo showing a masonry wall in the basement being demolished.

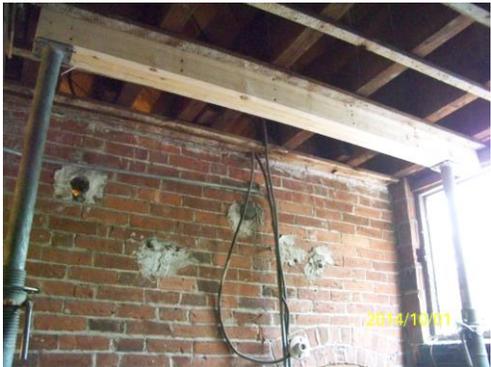
Photo showing additional shoring in place in order to demolish a masonry wall.

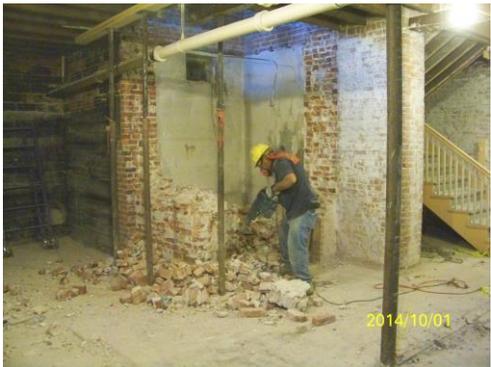
Photo showing another masonry wall being demolished. This is in the basement.
