PROJECT REPRESENTATIVE'S DAILY REPORT

Pg. 1
 Report No. 049
 Date: 2014-10-27
 Day: Monday

Architect: Kang Associates
Project: Renovation and Addition to Tewksbury Town Hall
OPM: CBI Consulting Inc. **Clerk of the Works:** Jeff Barnes
Contractor: G.V.W., Inc.

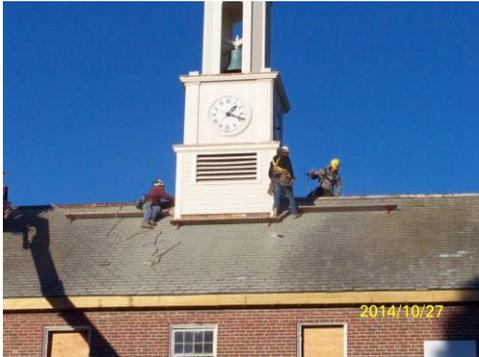
- 1) Carpenters are working on the base of the cupola removing the bottom trim and siding sections for the flashing and waterproofing to be installed. Once this is complete, the carpenters will continue to work on installing the framework in the attic.

Photo showing the carpenters working on the base of the cupola.

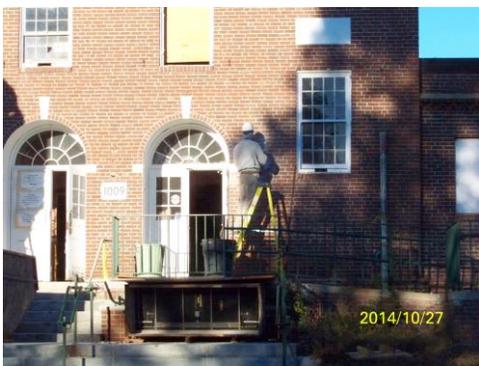
Photo showing a mason removing embedded metal and remaining fixtures.

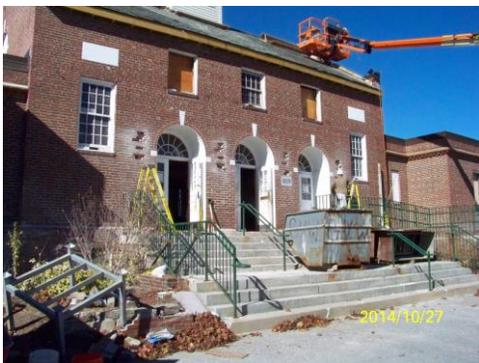
Photo showing areas on the east elevation where the remaining light fixtures and embedments were removed.

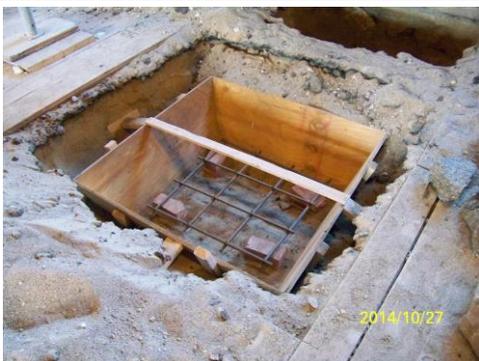
- 3) The demo crew is continuing to remove debris from the basement. One rebar cage was installed at the bottom of one footing. It is too high and will need to be lowered.

Photo showing footing formwork with rebar cage at the bottom. The engineer observed during his site visit that the cage is too high and that it needs to be lowered.

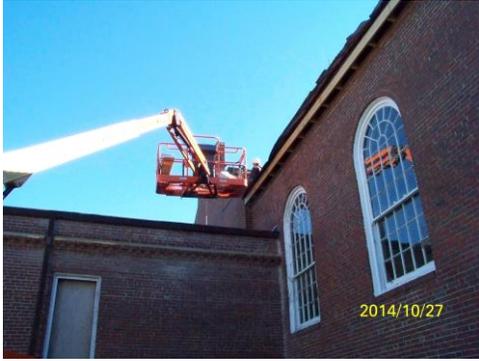
Photo showing mason working on the west side of the north elevation installing step flashing.

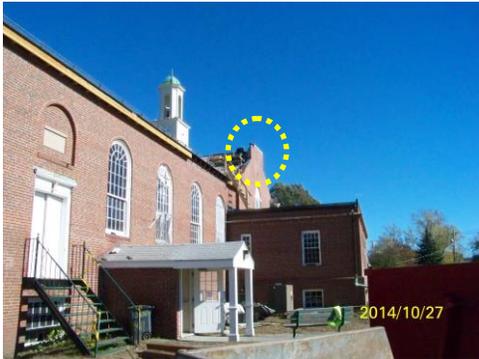
Photo showing mason working on the masonry where the chimney was located on the south elevation, west side.
