PHOTO INDEX

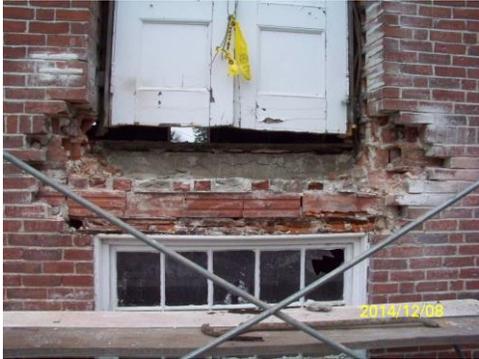
Photo showing the removed sill and lintel from the north elevation of the meeting hall.

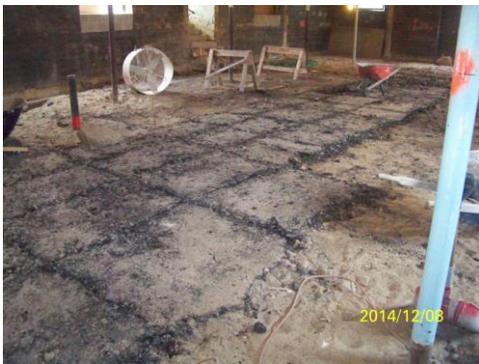
Photo showing asphalt cut into sections for easier removal.

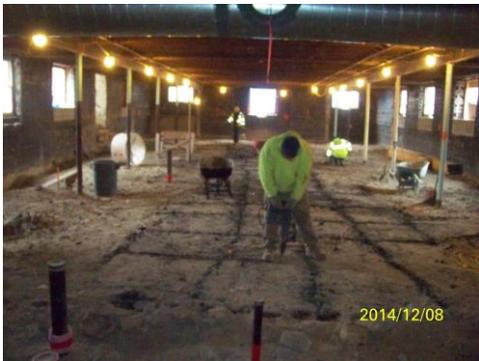
Photo showing workmen removing the asphalt course from the basement.

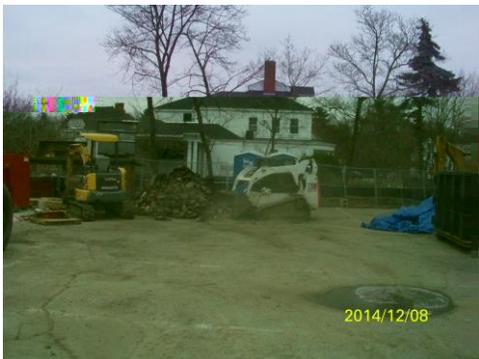
Photo showing equipment operator stockpiling asphalt for removal from site.

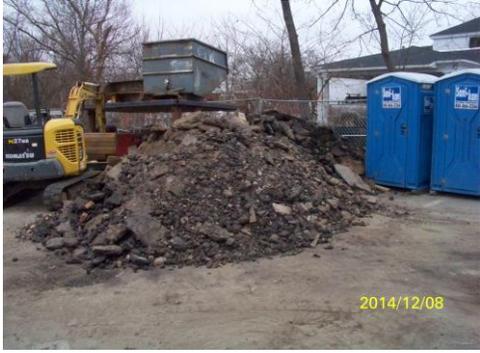
Photo showing stockpiled asphalt.

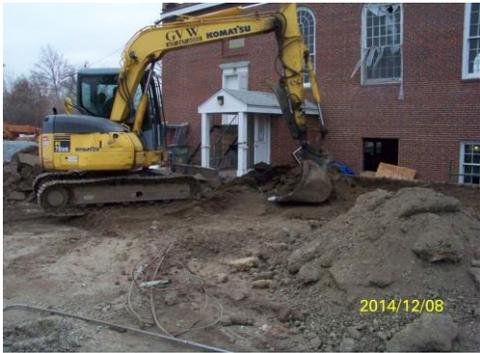
Photo showing workman prepping the area for the foundation excavation at the south side of the meeting hall.

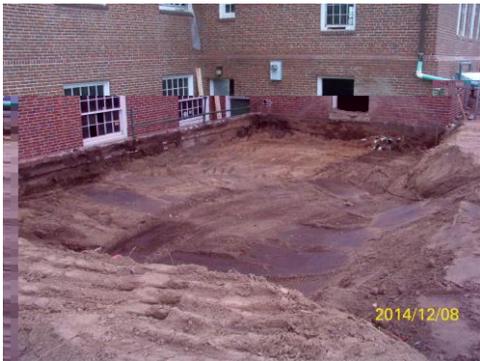
Photo showing area for the foundation excavation.

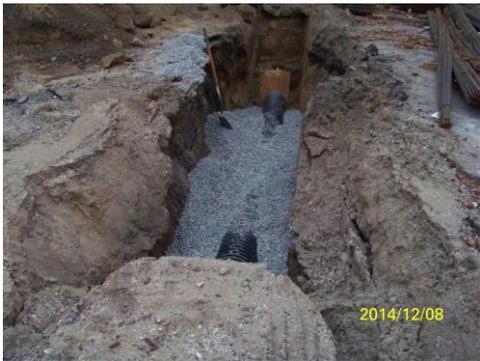
Photo showing catch basin drain pipe in place for connection to the street.

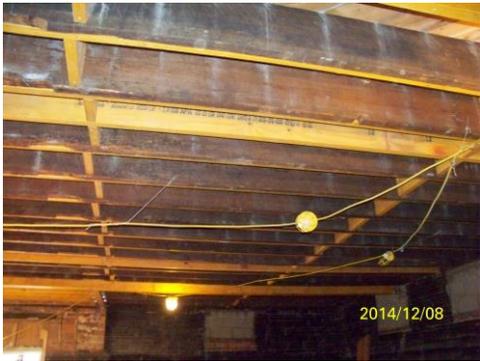
Photo showing a portion of the bridging and blocking in place.

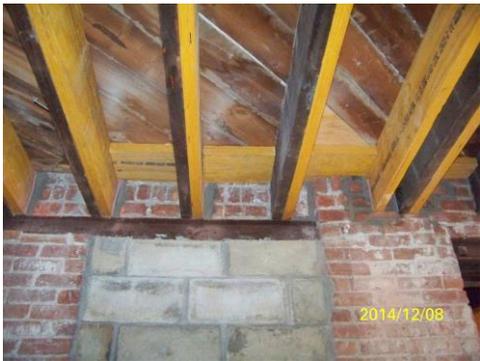
Photo showing bridging and blocking in place at the ends of the joists.

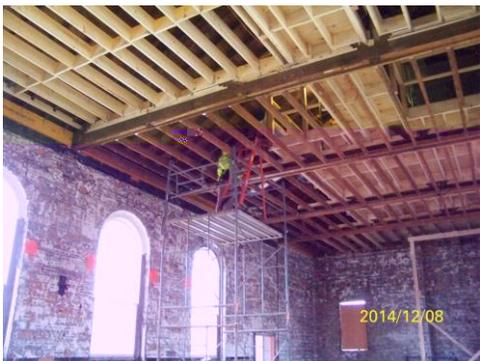
Photo showing HVAC workman setting up to install ductwork outside of the platform.

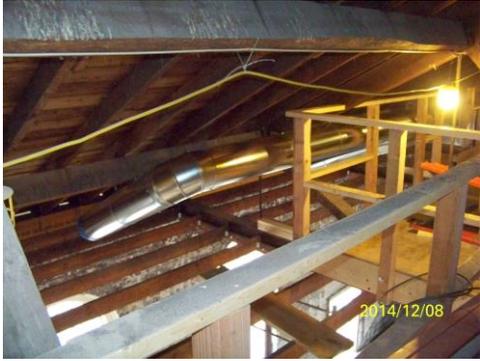
Photo showing ductwork installed outside of the platform.

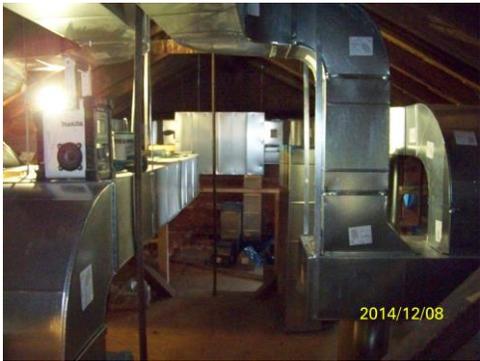
Photo showing ductwork assembly in place in the attic.
