PHOTO INDEX

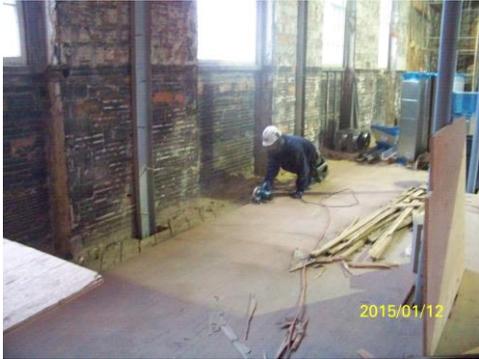
Photo showing carpenter starting to remove the existing hardwood flooring from the meeting hall along the south elevation. This revealed deteriorated subflooring that will need to be replaced.

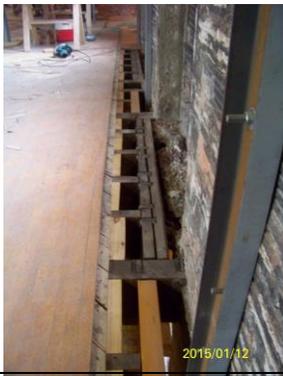
Photo showing removed flooring and subfloor and exposing the 1st floor framing.

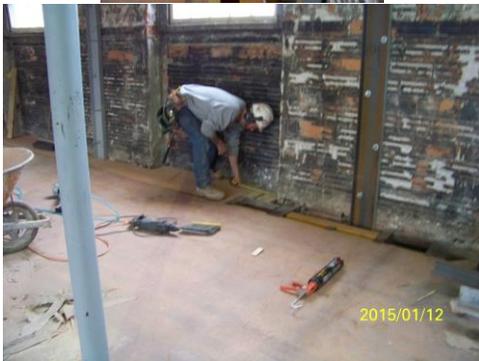
Photo showing carpenter measuring and placing plywood subfloor.

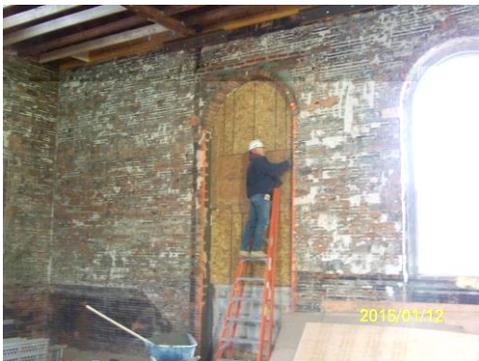
Photo showing mason patching over holes and voids at the new window opening on the north elevation of the meeting hall.

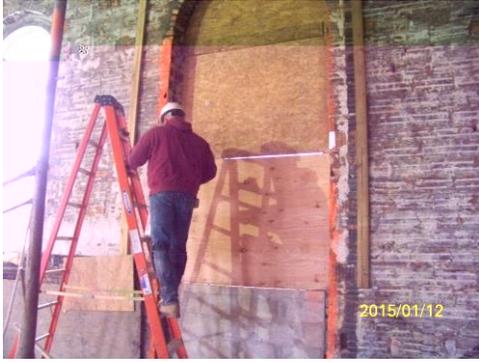
Photo showing mason working on the new window opening on the south elevation of the meeting hall.

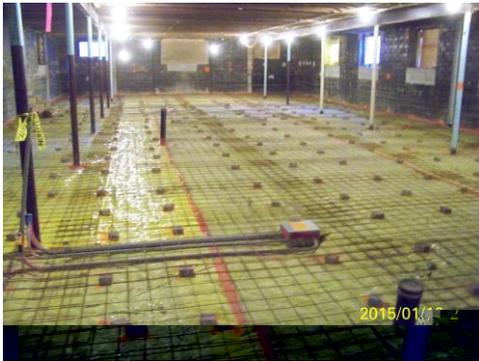
Photo showing mesh reinforcement in place in the main basement ready for concrete tomorrow.

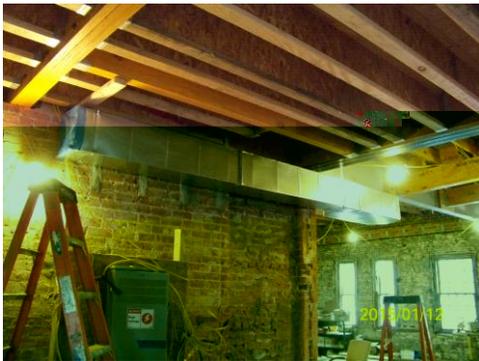
Photo showing some of the ductwork that was installed for the 1st floor.

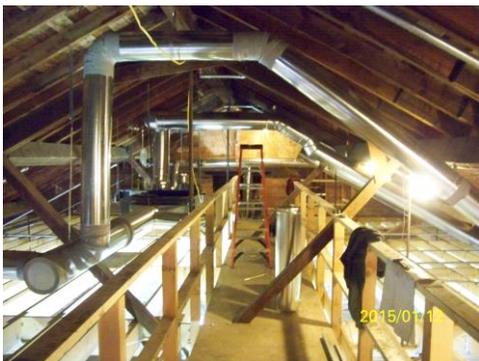
Photo showing more ductwork in place in the attic.

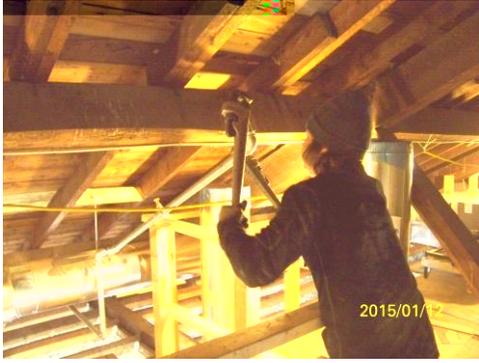
Photo showing workman installing sprinkler piping in the attic.

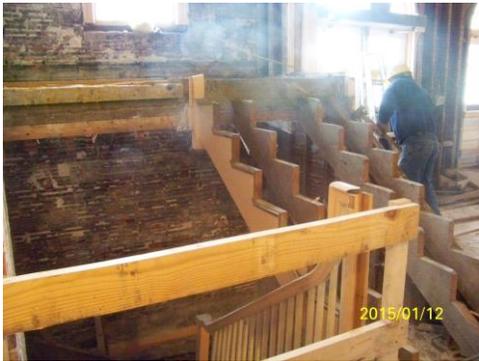
Photo showing the rest of the north stairs being demolished.

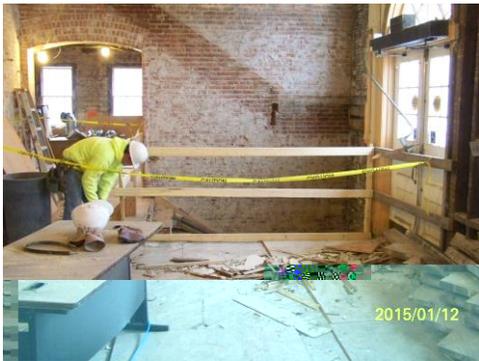
Photo showing north stairs demolished.

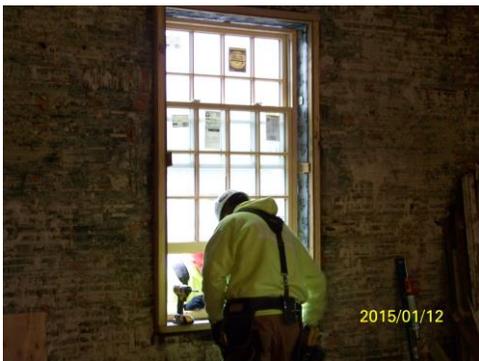
Photo showing carpenter installing the window mock-up on the east elevation of the south wing.

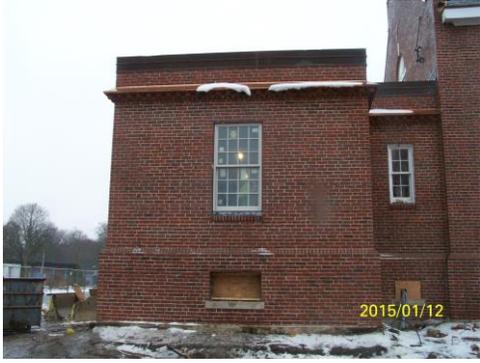
Photo showing window mock-up in place.
