PHOTO INDEX

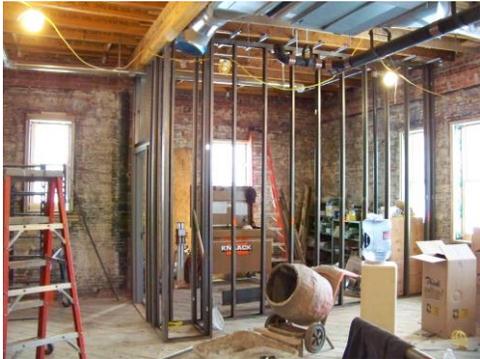
Photo showing the stud wall framing for the Clerk's office.

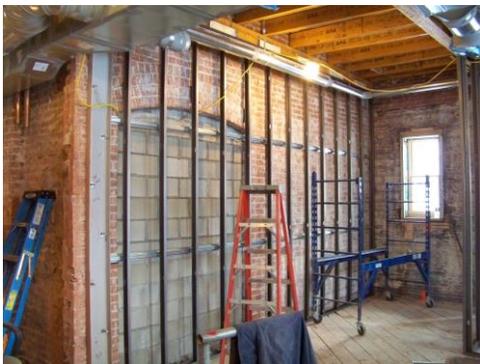
Photo showing some stud wall framing in place on the 1st floor. This is looking northeast in the Clerk's office.

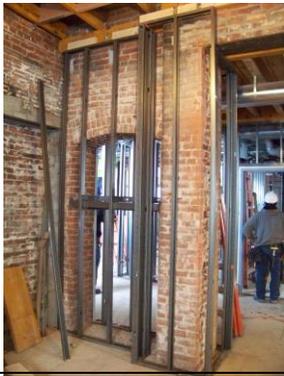
Photo showing stud wall framing in place on the 1st floor.

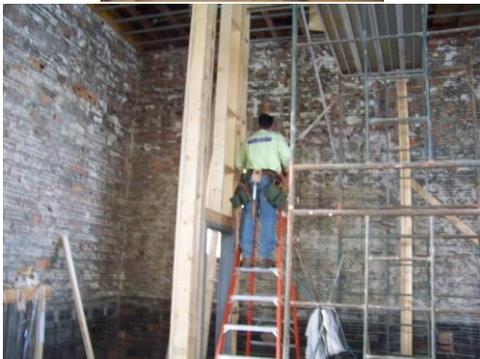
Photo showing carpenter working on the stud wall framing for the south end of the platform at the west end of the meeting hall.

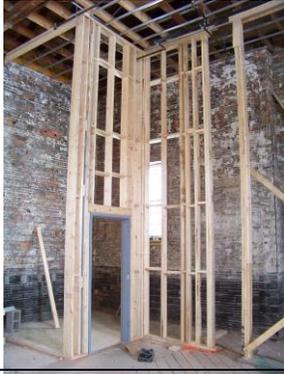
Photo showing stud wall framing of south end of platform.

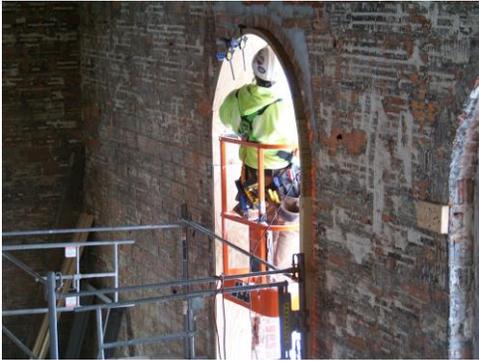
Photo showing carpenter installing blocking for a window mock-up in the meeting hall. This is on the north elevation.

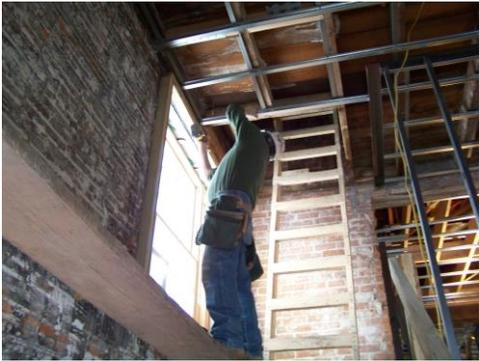
Photo showing carpenter installing furring on the 2nd floor ceiling.

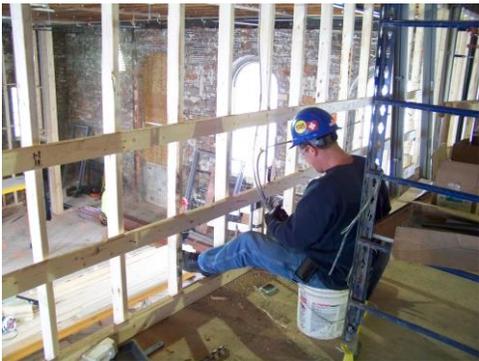
Photo showing carpenter installing rough wiring on the 2nd floor.

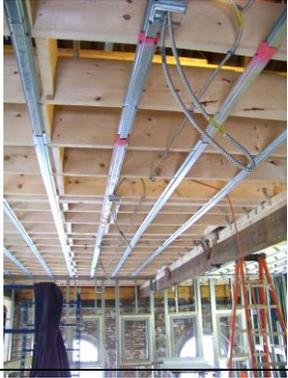
Photo showing rough wiring for surface mounted light fixtures.

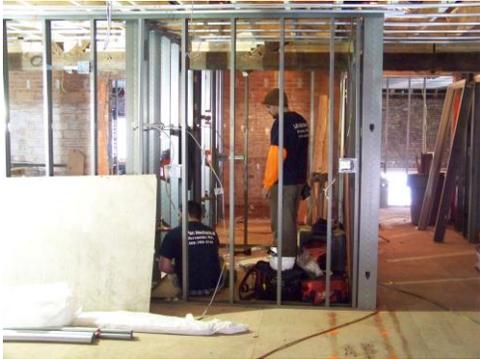
Photo showing plumbers working on the 2nd floor bathroom.

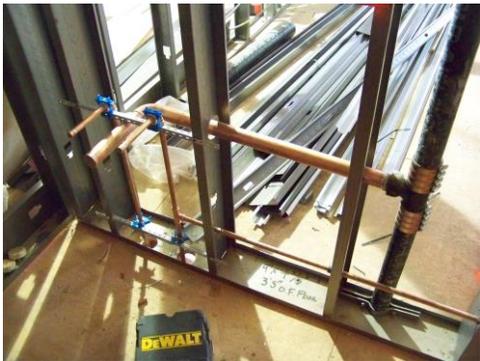
Photo showing plumbing rough work in place.

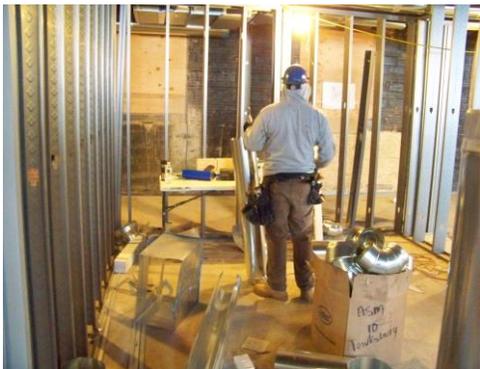
Photo showing tin knocker assembling ductwork for installation.
