**Tewksbury Water Treatment Plant  
Engineering Evaluation**

Final Report  
**Tewksbury Water Treatment Plant  
Engineering Evaluation**

## Water Treatment Plant Condition Assessment

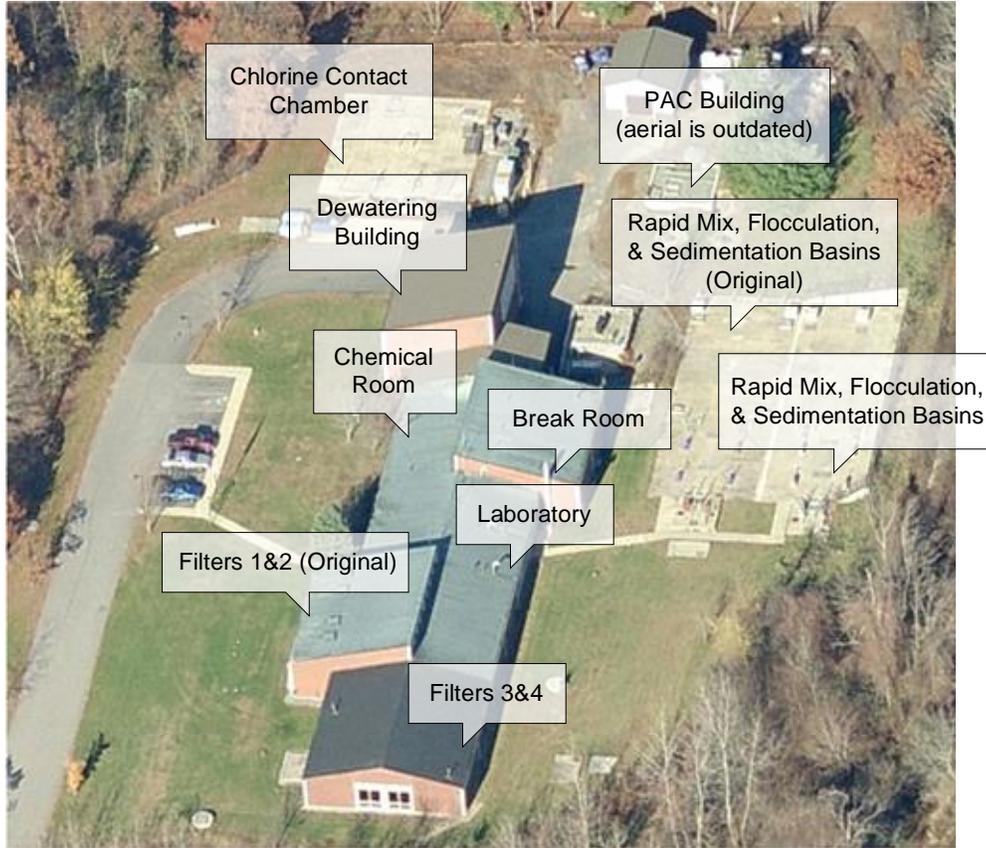
The TWTP is a 7 million gallons per day (MGD) facility consisting of conventional rapid mix, flocculation, and sedimentation basins, followed by automatic backwash (ABW) filters. The facility, originally constructed in 1988, was expanded in 2000 with the addition of two pretreatment trains (rapid mix, flocculation, and sedimentation) and two ABW filters. Vacuum filters were added as part of a dewatering addition in 2005. An aerial view of the facility is shown in Figure 2. Note that the powdered activated carbon (PAC) building had not yet been built at the time of this aerial photo. A process schematic is provided in Appendix A.

**Figure 2: Aerial View of the Tewksbury Water Treatment Plant**

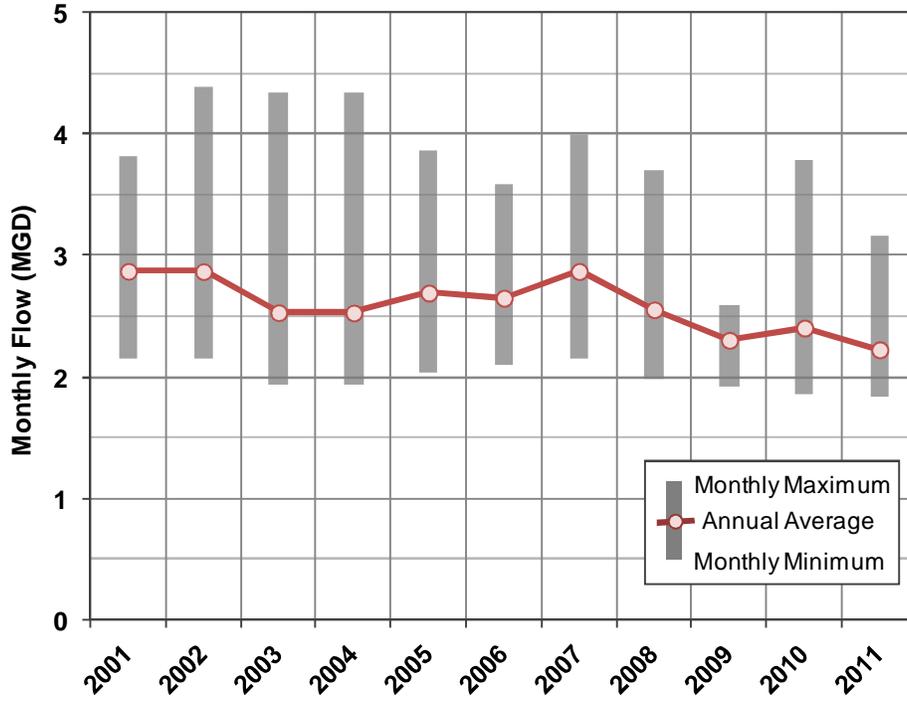
Average Day Demand (ADD), which corresponds to finished water pumping at the TWTP, has typically ranged between 2 MGD and 4 MGD over the last 10 years. The ADD was 2.40 MGD in 2010 and 2.23 MGD in 2011. The 2011 ADD was lower than the ADD in any of the preceding 10 years. TWTP flow between 2001 and 2011, including the annual average and the maximum and minimum monthly averages for each year is shown in Figure 4.

Figure 4: TWTP Monthly Finished Water Flow (2001 – 2011)

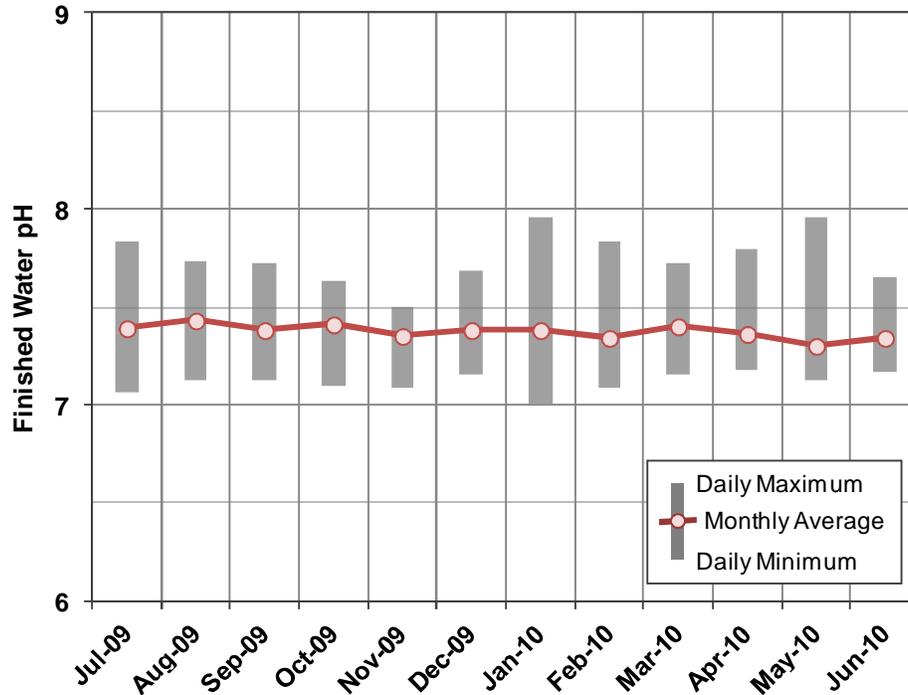
Dosing of sodium hydroxide and zinc orthophosphate is controlled to adequately stabilize the treated water to prevent corrosion and scaling in the distribution system. Hydrofluorosilicic acid is used for dental protection and is typically dosed at 0.8 mg/L. The pH of the finished water in 2009 and 2010 is shown in Figure 7.

**Figure 7: TWTP Finished Water pH (2009-2010)**

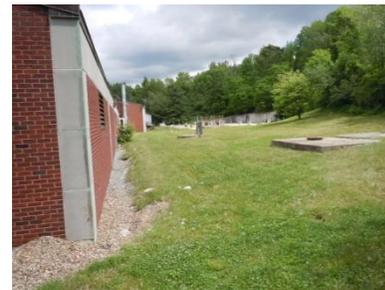
The TWTP site is relatively congested, with buried structures and pipes located throughout the property around the pretreatment area and the water treatment building. Grading is generally from the east to the west, with the property sheet draining to drains in the parking lot and roadways, or through a swale to the south of the filter addition.

**Figure 9: Grading East of Water Treatment Building**

The installation of an interceptor swale at the base of the back hill is recommended. This swale could direct runoff away from the facility to the existing swale located off of the southeast corner of the building.

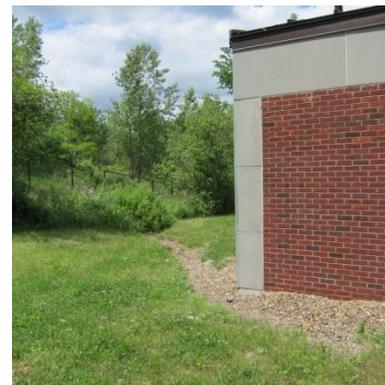
**Figure 10: Existing Swale on Southeast Corner of TWTP**

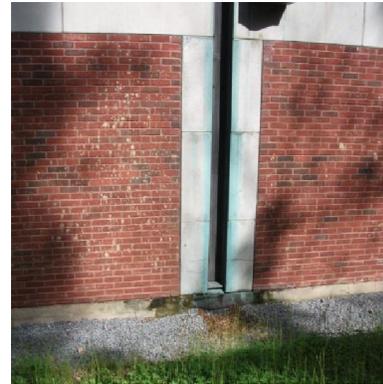
The structure appeared to be in “as-built” condition with some cosmetic faults discovered. There is freeze-thaw damage to the foundation concrete at the downspouts and concrete spalls and pockets are apparent in places on interior wall surfaces. Grating over the pipe trench is worn and a section is missing.

**Figure 11: Freeze-Thaw Damage at RW Pump Station**

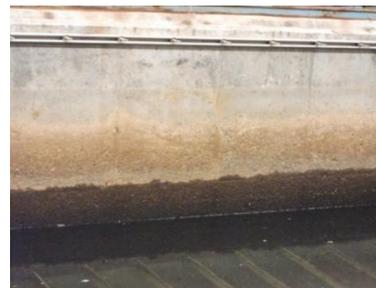
**Figure 12: Chlorine Damage on Filter Wall**

The structure appeared to be in fair condition with some cosmetic damage discovered that if left unchecked could lead to compromising the integrity of the structure. On the exterior of the building, there is freeze-thaw damage at the foundation concrete at downspouts. Filter walls exhibit early signs of corrosion due to chlorine damage at the water surface and outfall areas exhibit early signs of corrosion due to erosion caused by flowing water. Concrete coatings in the chemical area are damaged and are in need of repair.

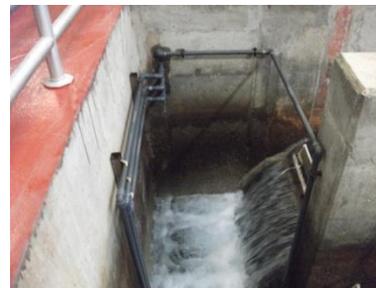
**Figure 13: Erosion Damage in Filters**

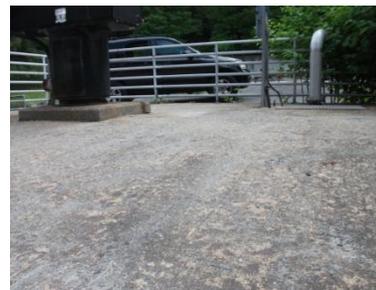
The top of the structure appeared to be in an 'exhibiting distress' condition with some cosmetic faults discovered that if left unchecked could lead to structural failure. This condition is due to the presence of spalling and cracked concrete that is apparent on the top surface of the entire tank.

**Figure 14: Freeze-Thaw Damage and Spalling on Sludge Tank**

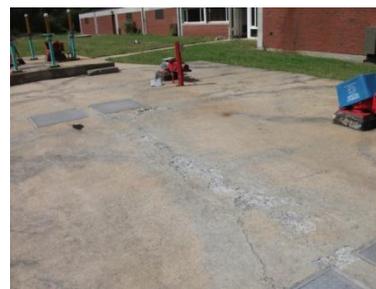
The structure appeared to be in fair condition with some cosmetic damage that if left unchecked could lead to compromising the integrity of the structure. Some areas of spalled and cracked concrete are apparent on the surface of the basins.

**Figure 15: Spalled and Cracked Concrete on Pretreatment Top Slab**

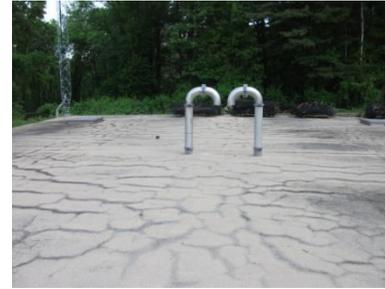
The structure appeared to be in fair condition with some cosmetic damage that if left unchecked could lead to compromising the integrity of the structure. Some areas of spalled and cracked concrete are apparent on the surface of the basins.

**Figure 16: Evidence of Drying Shrinkage of Outer Concrete Layer of Clearwell**

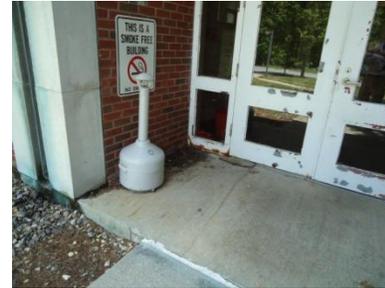
The east and west vestibule storefront window and door systems exhibit rusting at their base and chipped and peeling paint. The windows are single pane and do not conform to contemporary standards of thermal efficiency. The steel door at the lab exhibits peeling paint. The door for Office 112 is missing its lockset. Clerestory windows in the Filter Pump Room are full of condensate. All other exterior doors appear to be acceptable.

**Figure 18: West Entrance Doors**

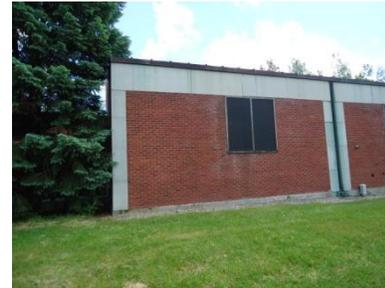
The standing seam copper roofs are generally in good condition. However, a greenish stain on precast and brick runs out from under roof fascia onto exterior walls at several locations of the original plant and the filter addition. This is evidence of leaking at the integral copper gutters in the roof directly above the walls. Snow guards are missing at locations above doors and some sections of copper fascia need repair.

**Figure 20: Staining from Leaking Gutters**

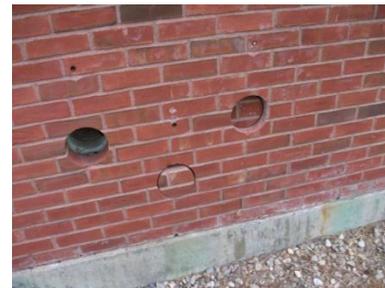
Three holes have been cored through the brick on the west façade of the original plant, with all or part of the core set loosely back in place. Evidence of pest activity is present within the wall.

**Figure 21: Holes Cored into West Façade**

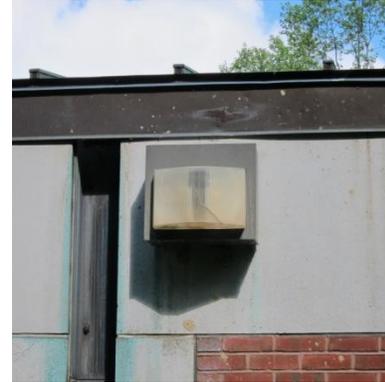
**Figure 22: Cracked Light at Raw Water Pump Station**

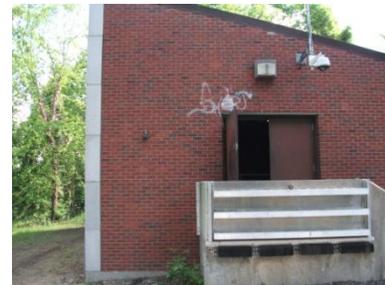
**Figure 23: Graffiti on Wall of Raw Water Pump Station**

The pump station door should be repainted and the lockset changed. A variety of treatments are available to remove the graffiti without damaging the masonry surface. Removal techniques, which are chosen according to the type of graffiti and the masonry, range from poulticing with water (with or without detergents), poulticing with organic solvents or alkali-based paint removers, or applying bleach to remove painted graffiti. Delicate and controlled abrasive means may be necessary in some situations.

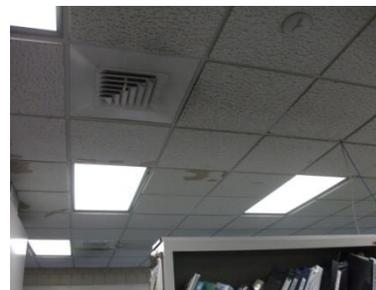
The laboratory has been in constant use since 1988, with little improvements made in that time. Cabinets exhibit rusting on their faces and have thoroughly rusted interiors in locations adjacent to wet areas. Painted CMU walls and ceiling tiles are stained, the latter from overhead pipe condensate. The seamless floor is marred in places from chemical spills and exhibits wear. Epoxy counter tops are largely in acceptable condition with some high use areas exhibiting chipping and flaking. There are no floor drains for general cleaning or to accommodate the emergency shower, and the emergency shower water is not tempered.

**Figure 24: ACTs in Laboratory**

Ceiling grid and tiles should be replaced, as should the flooring and cabinets. Walls should be cleaned and painted. Pipes in the ceiling should be insulated to prevent further staining. Floor drains for cleaning and to support the eye-wash and emergency shower should be installed, and cup sinks should be replaced with larger lab sinks.

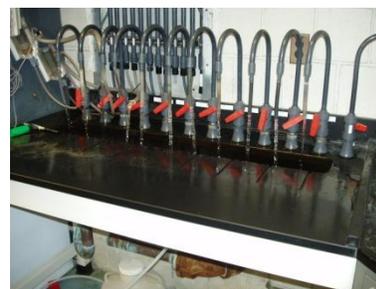
**Figure 25: Laboratory Sample Taps**

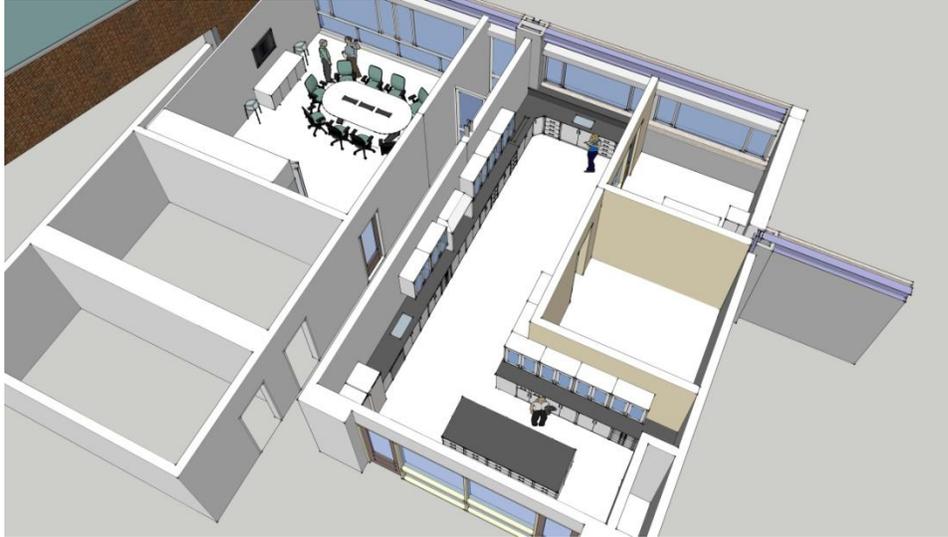
This layout, shown in Figure 26, creates an outside corner office and a windowless storage room in an enlarged lab space. The walls would be comprised of painted CMU. The perimeter of the room would be lined with work surfaces and equipment with space for file storage and a work surface island adjacent to the lab entry door. There are views into the lab from the control room via the existing glass, and a view into the lab from the office via vision glass in the office wall.

**Figure 26: Laboratory Layout 1 – Office and Storage Room**

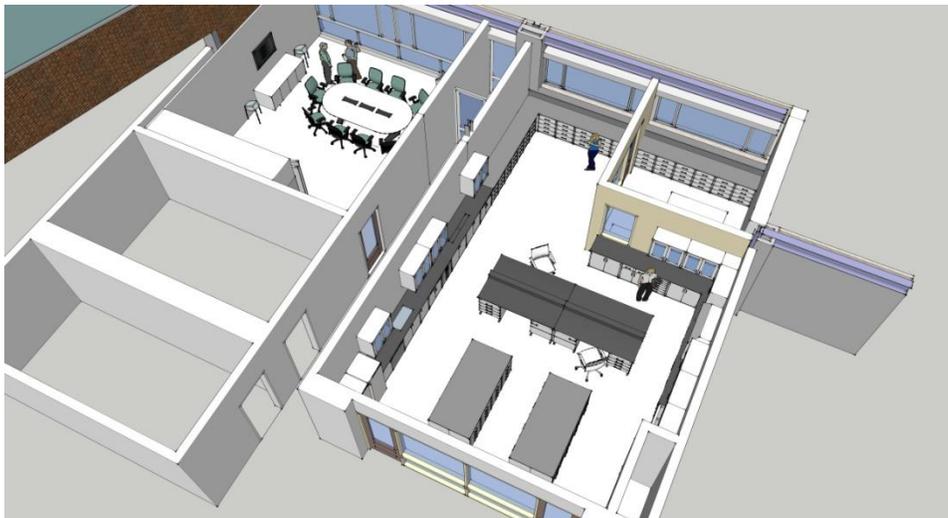
This layout, shown in Figure 27, creates an office at the outside corner of the lab space. A wider space for work surfaces and islands adjacent on the control room provides a wider open lab area. The existing window wall provides a view into the lab area from the control room, and a window in the office wall provides a view to the lab entry and control room from the office.

**Figure 27: Laboratory Layout 2 – Office at Outside Corner**

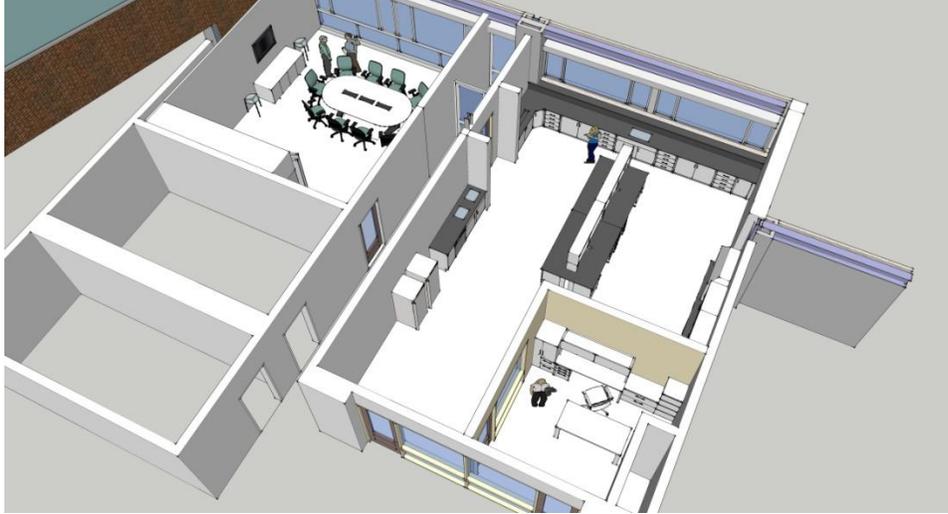
This layout, shown in Figure 28, places the office at the inside corner of the lab space, giving the office a dedicated entry door from the control room. This office also has a window into the lab space. The layout depicts reagent racks and shelves on the center island in the lab work space.

**Figure 28: Laboratory Layout 3 – Office at Inside Corner**

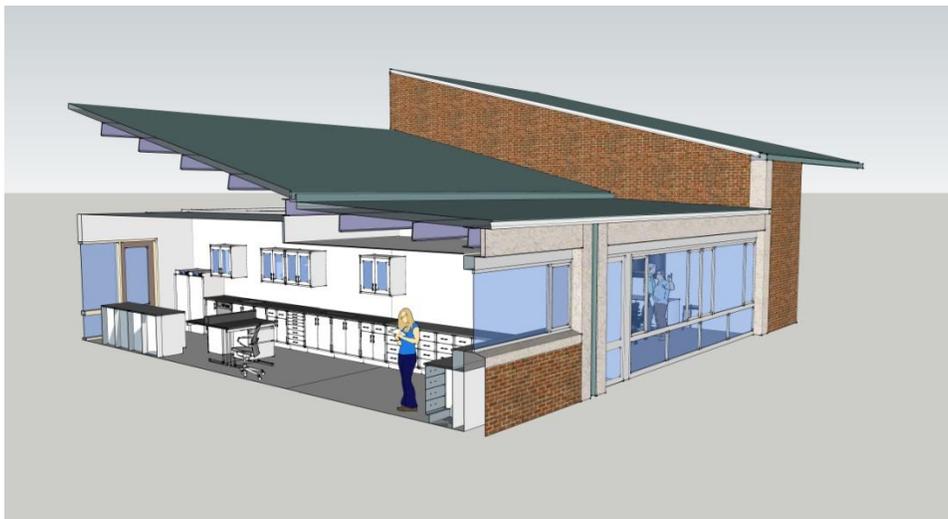
In order to accommodate the extension of the laboratory, the roof line has to be modified. Simply continuing the existing slope for the extension would result in an inadequate door height at the outside wall. A flat metal roof system for the extended area with a slope of 5/8 inch per foot is recommended for the building extension. This is the maximum slope after accounting for a transition area between the existing and new roof systems, as well as adequate room for the outside door and a beam above the door. A slope as shallow of 1/2 inch per foot would be acceptable. Maintaining a slope on the building is both aesthetically pleasing and still allows snow to slide off. Figure 29 shows the recommended building exterior.

**Figure 29: Laboratory Extension Roof Line**

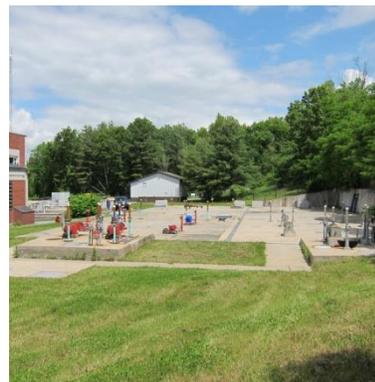
Pretreatment includes the raw water and recycled water meter vaults, as well as the rapid mix, flocculation, and sedimentation basins. A full assessment of these areas was not possible with all of the units in service, but a number of items were investigated at the Town's request. These items include:

**Figure 30: Pretreatment**

There is one rapid mix and two flocculator mixers in each pretreatment train, for a total of eight flocculator mixers and four rapid mixers. Although all equipment appears to be in good condition,

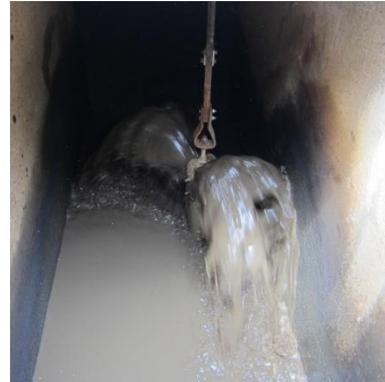
Sludge is transferred from the sump in each sedimentation basin to a sludge drain-off chamber via two 6 inch diameter telescoping sludge valves. Plant staff have indicated that the telescoping valves have had freezing issues in the winter, the sludge tanks require improved level measurement, some of the sludge piping needs to be replaced, and the mixer in the sludge holding tank (the old PAC storage tank) is oversized.

**Figure 31: Telescoping Sludge Valve**

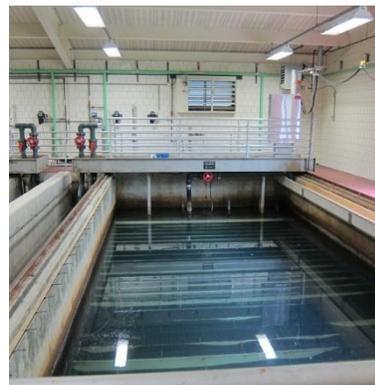
Filters are backwashed on a time basis every 24 hours. Backwashing is completed in two passes over 135 minutes at a rate of 10 gpm/ft<sup>2</sup>. ABW filters are considered rising head filters because filtered effluent feeds a fixed elevation effluent weir and there is no flow control valve. As headloss builds up within the filter media, the water level on top of the filter rises to maintain a constant flow rate.

Because headloss is not measured in the ABW filters, backwashes must be set on time. Whether or not 24 hours is an appropriate filter run time is based on experience. Although filter run times of 24 hours have been effective, they may be overly conservative. Spent washwater is recycled, so the facility is not wasting water. However, pumping and energy costs could be reduced with lengthened filter run times. Because it is difficult to measure headloss within the ABW filters, lengthening the filter run times would have to be an experimental process.

**Figure 32: GAC Filter**

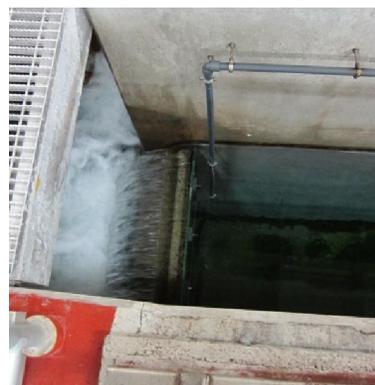
should be made compliant with Massachusetts State Building Code by the addition of a compliant screen or baluster system. There is some algae growth in the filter effluent channels, which could be addressed by tinting the windows in the filter area.

**Figure 33: Filter Effluent Channel**

Guardrails should be installed along the sides of Filter 1 and Filter 2. Any guardrails that may be in contact with non-employees should be retrofitted for compliance. Guardrails must be removable to allow access during carbon replacement. Windows in the filter area should be tinted to prevent further algae growth in the filter effluent channels.

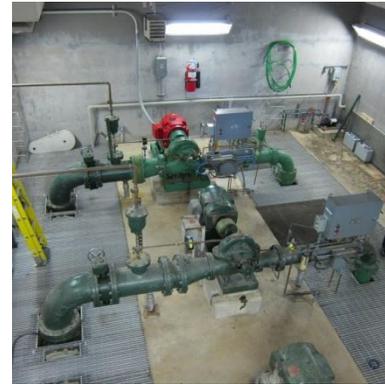
Pump No. 1 and No. 4 were replaced in 2000 with larger pumps rated for 3.6 MGD with 125 HP motors. Although new Parco control valves were installed in 2000, VFDs were subsequently added for flow control. These pumps appear to be in good working condition, have had no reported issues, and have reasonably even run times to date (22,536 hours for Pump No. 1 versus 27,851 hours for Pump No. 4). Piping and valves associated with these pumps appear to be in good working condition.

**Figure 34: Raw Water Pumps**

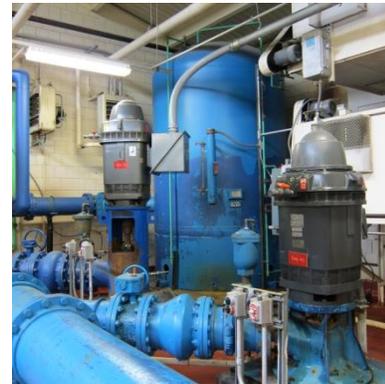
Pump No. 1 and No. 4 were upgraded and replaced in 1999. These pumps appear to be in good working order and have not yet had any rebuilding required. Pump No. 1 has a VFD and Pump No. 4 is constant speed; both are rated for 3.5 MGD. The associated piping and valves appear to be in good working order. However, it was noted that check valves slam and do not have a cushioned close.

**Figure 35: Distribution Pumps**

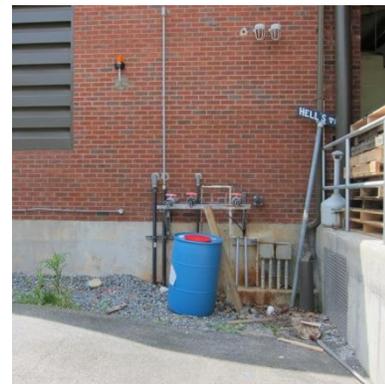
Individual containment is provided for hydrochloric acid and hydrofluosilicic acid in their storage rooms. Containment for alum, hypochlorite, and sodium hydroxide are located outside the building in three individual, buried, 6,000 gallon storage tanks. Overflow pipes connected to the exterior containment tanks have been installed within the curbed containment in the chemical area. Sodium chlorite and zinc orthophosphate containment is provided by the concrete berms in the chemical room. MassDEP (2009) requires that containment must be sufficiently large to store 110 percent of the total bulk storage tank volume. Any changes to bulk storage will require the plant to maintain compliance with MassDEP containment requirements.

**Figure 36: Chemical Fill Area**

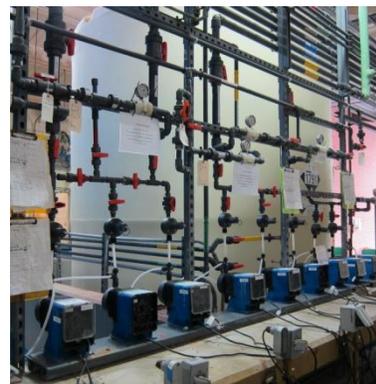
**Figure 37: Metering Pumps**

Existing metering pumps appear to be working without any issues. Solenoid operated diaphragm pumps that have been operating for ten to twelve years are near the end of their design life. Although rebuilding the metering pumps has been effective to date, pumps should be replaced. Standby pumps should be installed to provide redundancy. Even if rebuild kits are provided, standby pumps are still recommended. Controls for the metering pumps should comply with MassDEP drinking water regulations.

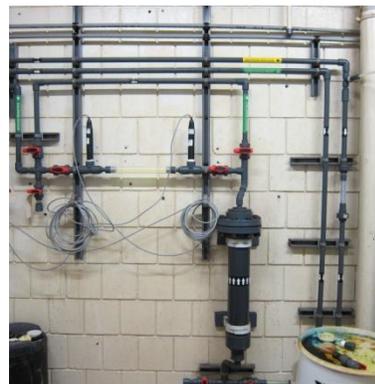
The existing chlorine dioxide system is 10 to 12 years old and was built by TWTP staff. To date, the system has been operating efficiently since installation, although some corrosion was observed on the generation unit hardware.

**Figure 38: Chlorine Dioxide Generator**

Reactant chemicals (sodium chlorite and hydrochloric acid) should be supplied to the generation unit from day tanks, which should be stored in separate rooms to prevent accidental mixing. If the day tanks are stored in the same room, separate containment will be required for each tank. Containment will be required for the entire chlorine dioxide system and reagents.

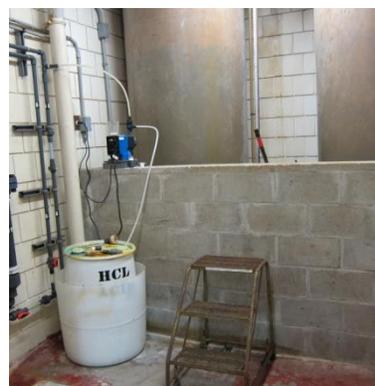
The plant currently uses hydrochloric acid as a part of the chlorine dioxide generation system. Hydrochloric acid storage is located in a separate room with the chlorine dioxide generator. Two polypropylene bulk storage tanks are filled from a connection on the exterior of the building. The system currently has a single solenoid operated diaphragm metering pump, which is connected to the bulk storage tanks and pumps to the chlorine dioxide system. The bulk storage tanks and metering pumps are approximately 10 to 12 years old.

**Figure 39: HCl Storage**

Although the hydrochloric acid system is currently stored in a separate room, it can be stored in a room with other chemicals. Hydrochloric acid should be kept away from sodium chlorite as contact with sodium chlorite could produce toxic and explosive chlorine dioxide gas.

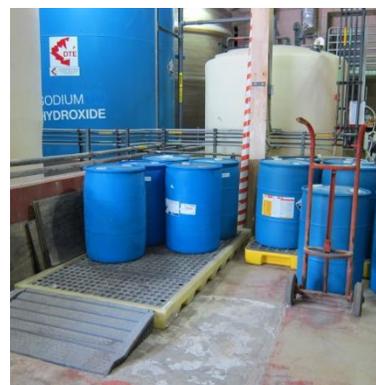
The current capacity of the bulk storage tank does not allow for sufficient capacity between deliveries. Delivery time for sodium chlorite can take several weeks and has been very unpredictable. The result of these delivery issues has forced the plant to store additional sodium chlorite in drums on a containment pallet adjacent to the bulk storage tank.

**Figure 40: Sodium Chlorite Drum Storage**

The sodium chlorite bulk storage tank capacity should be increased sufficiently to meet process demands and extended delivery time. This would eliminate the need to store sodium chlorite drums. The sodium chlorite system should be provided with a transfer pump and day tank. The bulk tank and day tanks should be vented to the exterior of the building and provided with an insect screen. Consideration should be given to moving the sodium chlorite system into the existing generator room to comply with current MassDEP requirements.

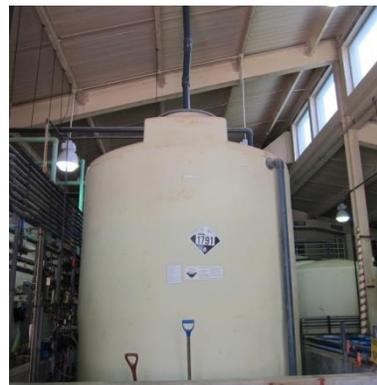
The sodium hypochlorite system is currently 10 to 12 years old. The system has been provided with a polyethylene bulk storage tank, filled from a connection located on the exterior of the building. Sodium hypochlorite is currently pumped from the bulk storage tank to the points of application with solenoid operated diaphragm pumps.

Access to the sodium hypochlorite area is very limited. Most of the area accessible from the corridor is blocked by the metering pumps, chemical piping, and miscellaneous supports. The bulk storage tank occupies most of the space within the containment area, which limits access around the tank.

**Figure 41: Sodium Hypochlorite Bulk Storage**

In the event of an emergency, and an operator needs to use an emergency shower or eyewash, there are many obstacles in the way to get out of the containment area. These obstacles do not allow the operator to quickly access the emergency shower or eyewash, which may result in greater injury.

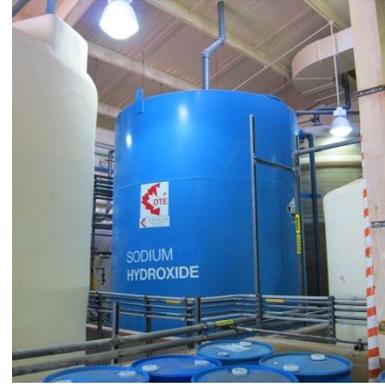
The sodium hydroxide system has been provided with a steel bulk storage tank. The bulk storage tank is filled from a connection located on the exterior of the building. Sodium hydroxide is currently pumped from the bulk storage tank to the points of application with solenoid operated diaphragm pumps.

Access to the sodium hydroxide area is limited. Most of the area accessible from the corridor is blocked by metering pumps, chemical piping and miscellaneous piping. The bulk storage tank occupies most of the space within the containment area, which limits access around the tank and to piping. The sodium hydroxide area is also accessible from the sodium chlorite area.

**Figure 42: Sodium Hydroxide Bulk Storage**

In the event of an emergency and an operator needs to use an emergency shower or eyewash, there are many obstacles in the way to get out of the containment area. These obstacles do not allow the operator to quickly access the emergency shower or eyewash, which may result in greater injury.

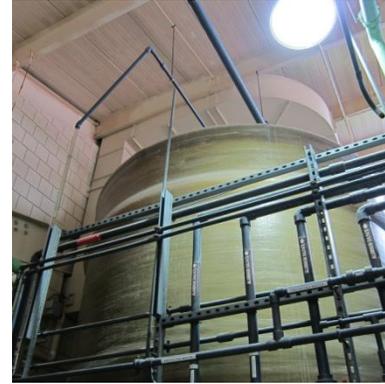
Although the bulk storage tanks appear to be in good condition, the tank manufacturer should be consulted for a more accurate assessment. The alum system should be provided with a transfer pump and day tank. The day tank material should be polyethylene or as preferred by operations staff. The existing metering pumps should be replaced and a standby pump should also be provided for each application point.

**Figure 43: Alum Bulk Storage**

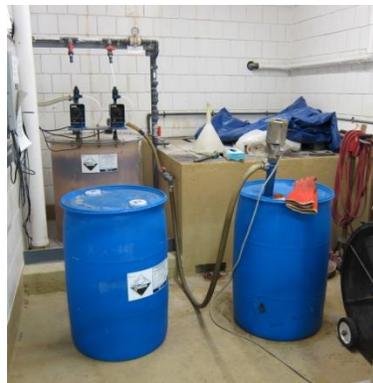
**Figure 44: Hydrofluorosilicic Acid Storage**

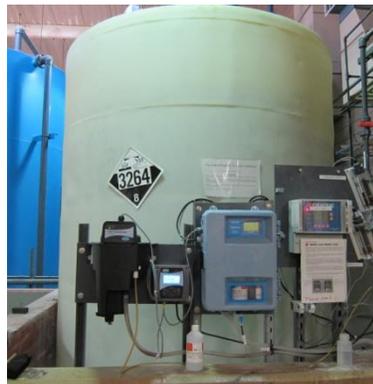
**Figure 45: Zinc Orthophosphate Bulk Storage**

The analyzers mounted within the zinc orthophosphate area should be relocated to increase the accessibility of the area and allow for operators to enter and exit the area safely. A ladder at the current location of the analyzers, with steps on the inside and outside of the curbed area would improve access.

The existing metering pump should be replaced and a standby pump should be provided for each application point. The bulk storage and day tank appear to be in good condition and no repairs or upgrades are required. Tanks should be vented to the exterior of the building and provided with an insect screen. The fill connection for the bulk storage tank should be moved to the exterior of the building.

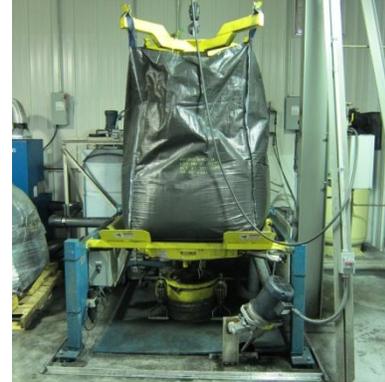
The PAC system is relatively new and is working well. The only issue identified with the PAC system is the cleaning of the dust collector. A large amount of carbon is released into the room when the dust collector bin has to be periodically emptied. Plant staff would prefer to provide a method to rinse the collected carbon from the dust collector back to the carbon slurry tank.

**Figure 46: PAC Feeder**

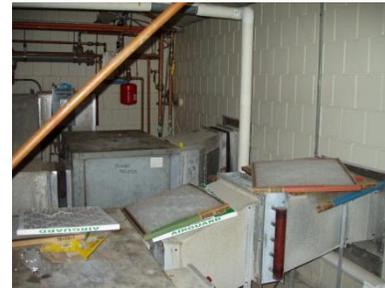
The existing systems were installed as part of the original facility construction. Air handling and air conditioning units are located on the mezzanine above the restrooms. The exhaust fan that serves the administrative areas is also located in the mezzanine, with separate exhaust fans for the fume hood and canopy hood installed in the laboratory. Access to the equipment is difficult due to limited space within the mezzanine area. Some of the hot water piping to the air handling and air conditioning units was observed to be missing insulation.

**Figure 47: HVAC Equipment in Mezzanine**

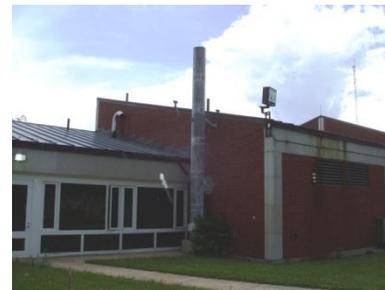
The boiler room systems were installed as part of the original plant construction. Room ventilation consists of a propeller supply fan drawing air from outside to the room. Heat is provided by a hydronic unit heater. Boiler exhaust is passed through the wall and up a stack attached to the side of the exterior wall.

**Figure 48: Boiler Stack**

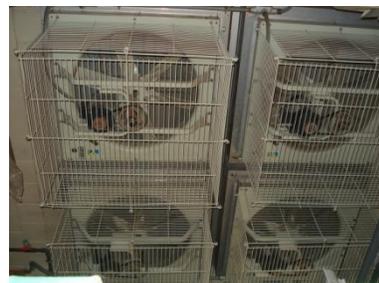
**Figure 49: Generator Room Exhaust Fan**

The generator room ventilation system was installed as part of the original plant construction. Ventilation consists of four propeller exhaust fans drawing outside air into the room through louvers with motor operated dampers. The room is heated by a hydronic unit heater.

The generator room ventilation system is at the end of its useful life. The system should be modified if the generator is replaced to match the requirements of the new generator. If the generator is installed outside the building, heating and ventilation should be coordinated with the rest of the chemical area.

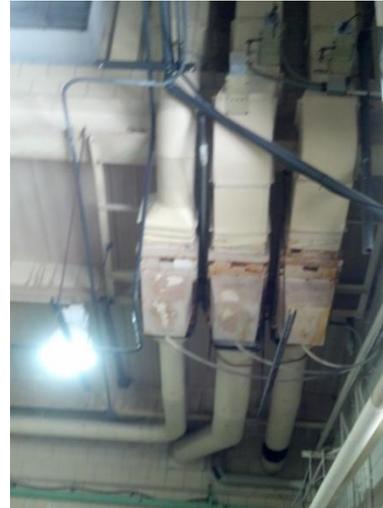
**Figure 50: Exhaust Fans in Chemical Area**

The existing chemical room systems were installed as part of the original plant construction and equipment are showing signs of corrosion. The air handling unit supplying the space is located on the mezzanine above the restrooms. Ventilation for the smaller chemical rooms, shop, storage room, and utility room is accomplished by drawing in air from the large chemical room and by a transfer fan. Exhaust fans are connected to the hydrofluorosilicic acid and hydrochloric acid rooms. The shop, storage, and utility rooms are exhausted through the hydrochloric acid storage room. A transfer grill located in the wall between the fluoride and hydrochloric acid rooms is corroded.

The existing systems are at the end of their useful life. All systems serving the chemical areas should be replaced. The ventilation systems for the smaller chemical rooms should be kept segregated from each other and the general chemical room. Dampers should be installed in each room so that air is not transferred into the main area should the ventilation system be shut off. The transfer grill in the wall between the fluoride and hydrochloric acid rooms should be eliminated and the wall sealed.

All HVAC equipment and ductwork in or serving the chemical rooms should be replaced with corrosion resistant materials. New systems with sufficient air changes per hour and proper corrosion resistant materials for the fans and ductwork are recommended.

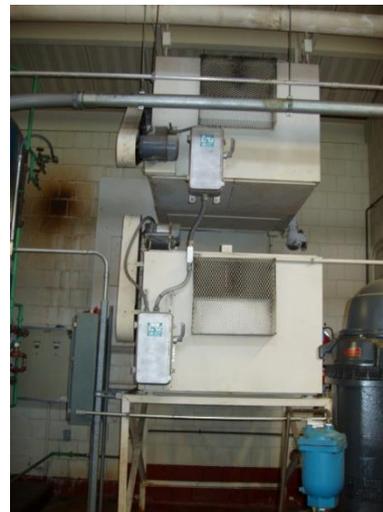
**Figure 51: Air Handling Units in Filter Room**

The original filter room is served by two air handling units, which provide filtered outside air. Air is exhausted through wall louvers with motor operated dampers. Perimeter heating is provided by hydronic unit heaters in the original section, which have visible signs of corrosion.

The newer filter room is served by a separate air handling unit that provides filtered and heated outside air. The air handling unit has hydronic heating coils. A fan was installed with the

filter addition to transfer air from the older filter room to the newer section. Air is exhausted through wall louvers with motor operated dampers. Perimeter heating is provided by two gas fire unit heaters. All equipment in the new section appears to be in good condition.

Heating coils to one of the air handling units are recommended for heated winter ventilation. A split ductless system for the filter electrical room is recommended to provide sufficient cooling for the VFD. The split ductless unit could be installed above the door of the room.

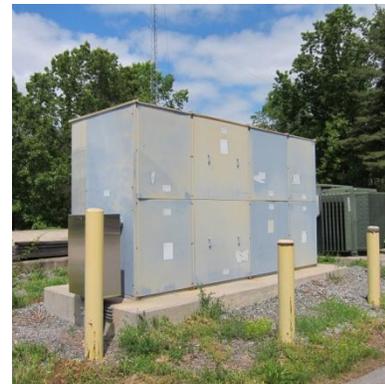
**Figure 53: Main Switchboard**

The main 480V distribution system for the facility is located within an outdoor NEMA 3R metal enclosure adjacent to the facility utility transformer. The facility electrical load was identified to be approximately 269 kW at 0.95 PF during the equipment review.

Inspection of the main switchboard found the exterior of the enclosure weathered and paint faded. Warning signage is barely visible. Dirt and sand debris with some frame and aluminum lug oxidation can be seen at the front and within the

opening of the enclosure. Although a NEMA 3R enclosure surrounds the electrical switchboard within an envelope that includes doors to prevent direct exposure to the elements, the enclosure is not sealed and has openings that allow moisture and dirt entry. Over time, this type of enclosure could result in premature equipment failure.

The main breaker is a 2,000 ampere Square D Type SE electronic trip circuit breaker with long time, short time, instantaneous and ground fault adjustable protection. Various dial settings are evident but no calibration stickers were found. Drawings indicate that lightning protection at the main service was provided when constructed. However, surge protection to UL 1449 is not provided. A revision of UL 1449 went into effect in 2007. This revision adds intermediate fault current tests for surge protection devices (SPDs). Before the 2007 revision, only high current fault current testing was specified.

A pre-fabricated structure placed over the switchboard is recommended to provide a clean and controlled environment for the main switchboard. It appears that there is adequate space in the area of the switchboard to allow this to happen. As part of this work, the following should also be performed:

The work required at the main switchboard, including placing the equipment within a weather-proof structure, the associated upgrades or replacement of the ATS, and the addition of surge protection should be performed immediately.

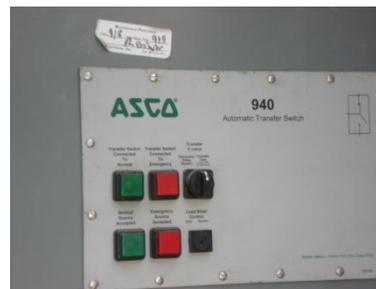
**Figure 54: Automatic Transfer Switch**

The automatic transfer switch (ATS) is an ASCO 940 series, which is an outdated style switch and no longer manufactured. There is a sticker on the enclosure that indicates that an ASCO field representative was at the facility in 2008. This was in response to an incident where transfer to the generator did not occur during a utility outage, resulting in the plant operator having to open the enclosure and manually operate the switch with a removable handle to transfer the facility load to the generator. It is believed that the adverse conditions of the environment caused the ATS to fail to operate. Discussion with plant staff indicated that the generator is tested without using the ATS and not tested under load. The existing electrical system installation has a single point of failure at the ATS. The ATS is not exercised and its status is unknown.

Operation of the transfer switch using the manual operating handle with the ATS protective door open is a hazard due to the dangers of arc flash if one of the two sources are energized. The best way to remove the hazards of an arc flash is to de-energize electrical equipment when interacting with it, however de-energizing electrical equipment by operating circuit breakers is in and of itself an arc flash hazard. No arc flash labels were found on the electrical distribution equipment.

- A bypass switch should be added to permit exercising of the transfer switch.
- A field technician from the ATS manufacturer (ASCO) should be brought on site to perform switch contact timing calibration check and to determine if the switchboard/ATS installation can be modified to provide an external operating handle to allow the operator to manually transfer the load more safely in an emergency (alternatively, the ATS can be replaced).

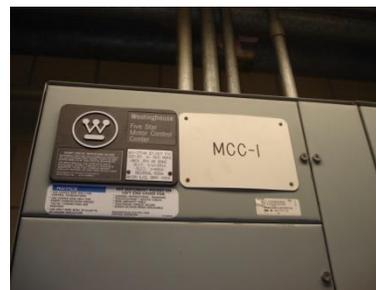
Figure 55: TWTP MCC 1

- **Electrical Room – 121 – MCC-1, MCC-1-A, MCC-2 and MCC-2A:** MCC-1 and MCC-2 were manufactured by Westinghouse Company (Series 2100) and date back to the original plant construction, while MCC-1A and MCC-2A were manufactured by Square D Company and were installed during the 1998 expansion. All MCCs appear to be in good condition. MCC-2A is located partially across the aisle from MCC-2 and a working clearance in front of these MCCs is not quite the NEC required

four feet between 480V distribution enclosures. These MCCs were originally designed with reduced voltage starters to power 2-100 HP and 2-200 HP high lift pumps. Presently, VFDs have been provided to power the 100 HP Pump No. 3 and the 200 HP Pump No. 1. It was noted that of the four pump motors, only the Pump No. 2 motor is inverter duty rated. A VFD-driven general purpose motor can overheat if it is run too slowly as motors can get hot if they are run slower than their rated speed. Since most general purpose motors cool themselves with shaft-mounted fans, slow speeds mean less cooling. If the motor overheats, bearing and insulation life will be reduced. There are therefore minimum speed requirements for all motors. The 'voltage chopping' that occurs in the drive actually sends high-voltage spikes (at the DC bus level) down the wire to the motor where a reflected wave occurs at the motor. The reflected wave can effectively double the voltage on the wire, leading to premature failure of the motor insulation

- Surge protection to UL 1449, 3<sup>rd</sup> edition should be added to the MCCs.
- Replace Reeves Drives with VFD/motor/gear reducer combos.
- When VFDs are added in the future, new cabling that uses separate raceways for the power conductors to the motors should be provided.
- Motors driven by new VFDs should be changed to inverter duty rated type or dV/dt output filters should be included in the VFD enclosures.
- Panelboard P1 should be designated for interior inspection and possible replacement.
- Further review of the PAC system should be performed as part of the preliminary design effort of upgrades to determine if replacement of the electrical system with explosion proof enclosures and conduit seal fittings is warranted.

The addition of surge protection at all MCCs should be performed immediately including replacing the TVSS at MCC-6. Existing VFD cabling should be reviewed and replaced if found not to be installed in accordance with good engineering practice. Panelboard P1 should be evaluated for condition and possible replacement within the next few years.

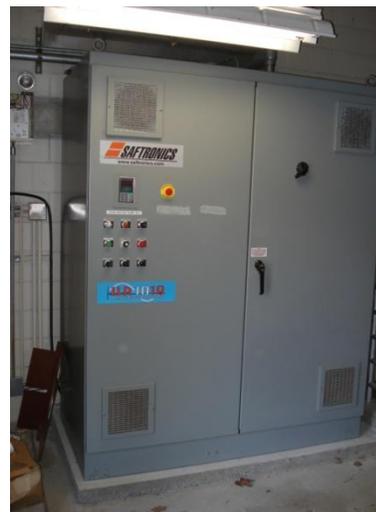
**Figure 56: Raw Water Pump VFD Cabinet**

Large VFDs are installed at the Raw Water Pump Station and in the area adjacent to the filters for two high lift pumps. The existing Safetronics style VFDs appear to be an older vintage and consideration for future replacement of these drives may be warranted since the life expectancy of a drive system is not only based on usage, but improved technology and obsolescence of older parts. The Yaskawa drive for High Lift Pump No. 1 appears to be a recent addition to the facility and includes an integral cooling system.

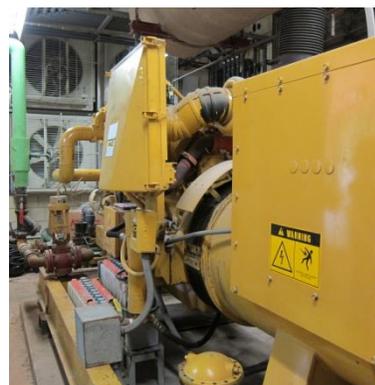
**Figure 57: Standby Generator**

The existing 500 kW, 480V 3-phase standby generator system consists of a water cooled Caterpillar diesel engine and generator on a common skid. As reported by plant staff, the system is not tested under load. The jacket water keep warm system was found to be functional. The nickel-cadmium starting batteries were found to have clean terminals and be in good condition.

The controls for the generator are located in a relay based free-standing control panel manufactured by Enercon. This relay based type control panel is no longer supplied by engine

generator manufacturers. Any operational problems with the wiring or devices within the panel would be difficult and time consuming to remedy. Therefore, this type of panel can be considered a 'weak link' with respect to the reliability of the standby power source.

The engine is cooled by a 'once-through' water service that is connected to the engine's heat exchanger and then discharged to the river. Not only is this a waste of water resources, but it could result in direct contact to engine fluids if a crack in the block occurred. Since this installation is contrary to LEED initiatives, replacement of this system should be considered.

A replacement diesel fueled standby generator system with a dual walled diesel fuel belly tank in a weather proof walk-in enclosure system should be provided. It should be sized between 600 kW and 750 kW depending on future facility demand needs and the ability to reduce existing kW demand by installing additional VFDs at the facility. Replacement of the standby generator system should be considered immediately.
